THE ROLE OF SONOGRAPHY IN THE DIAGNOSIS OF TRAUMATIC RUPTURE OF THE ANTERIOR CRUCIATE LIGAMENT OF THE KNEE

Piyadara KHONGPIBOONKIT,¹ Chairat KHONGPIBOONKIT,²
Worachai AUEAPINUN,² Anun MALAIRUNGSAKUL²

²Department of Orthopaedics, Phayao Hospital, Phayao, THAILAND 56000

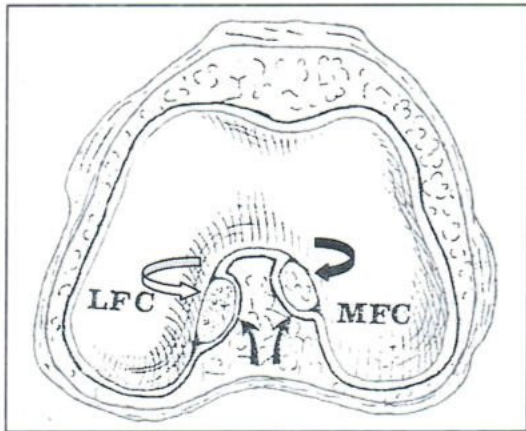
Fig.1A Anatomic drawing shows femoral intercondylar notch in cross section. Anterior cruciate ligament(white arrow) originates from medial aspect of lateral femoral condyle (LFC). Posterior cruciate ligament(black arrow) lies against medial femoral condyle (MFC). A synovial membrane (curve black arrows) envelopes both ligaments.

A transverse scan of the intercondylar notch was taken as the standard plane for the assessment of the anterior cruciate ligament.² The scan clearly showed both walls of the notch, the smooth hypoechoic concave synovium, and the popliteal artery lying just posterior to the lateral femoral condyle. The hypoechoic synovium, which is 2–3 mm. thick, lies parallel to the bony outline. Echogenic intercondylar fat lies centrally. (Fig 1, Fig 2)

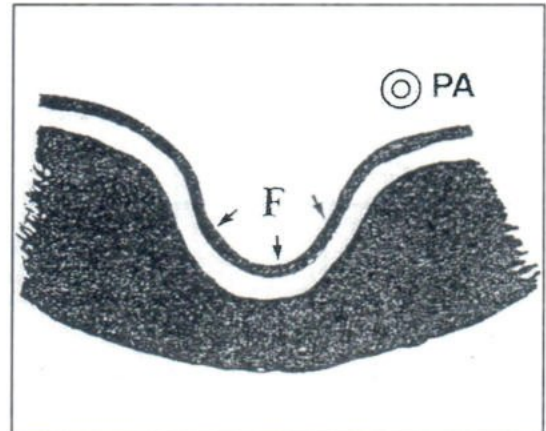
Fig.1B

Fig 1B Anatomic drawing of findings on transverse sonogram taken of region in A shows curves of femoral intercondylar notch, covering synovium(arrows),intercondylar fat (F) and popliteal artery (PA)

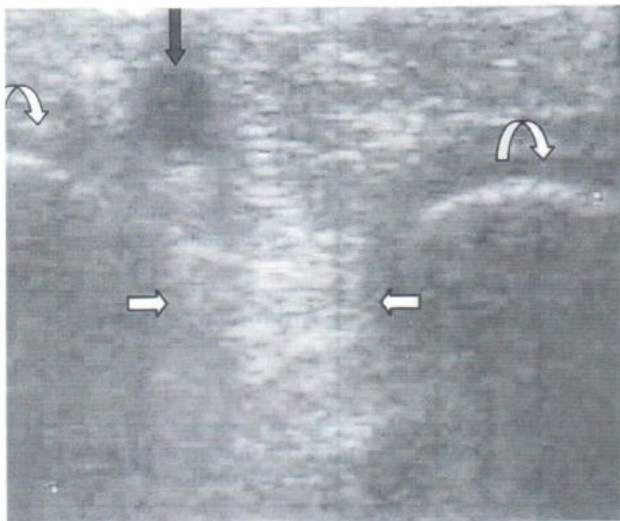
Fig.2 A A transverse scan of the intercondylar notch of **left** knee showed both walls of the notch (white arrows), the hypoechoic concave synovium (curve arrow), and the popliteal artery (black arrow).

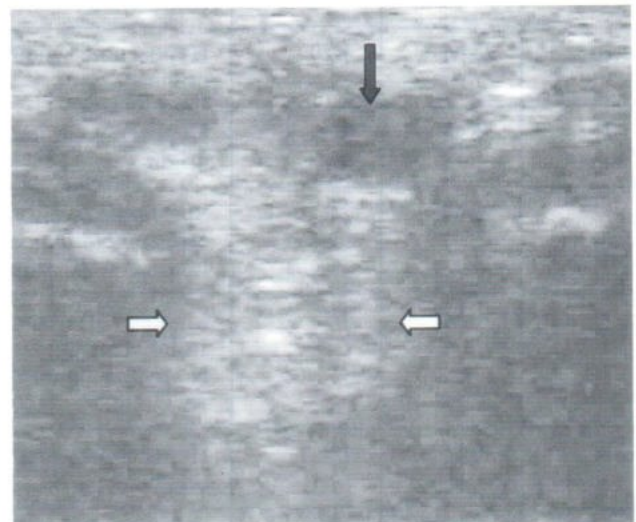
Fig.2 A

Fig.2 B A transverse scan of the intercondylar notch of **right** knee.

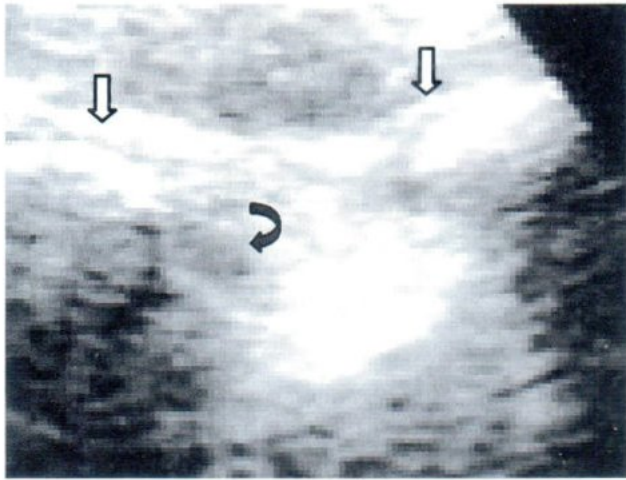
Fig. 3 A Sonogram of case 5 shows a 8x12 mm. hypoechoic collection representing hematoma, at lateral wall of left femoral intercondylar notch (curved black arrow Hypoechoic synovium lies papallel the femoral condyles (white arrows). Knee operation revealed ACL disruption at femoral attachment and a hematoma at ACL origin.

cruciate ligament is thought to represent a hematoma near the origin of the anterior cruciate ligament³ together with the anterior cruciate ligament stump in the cases of a complete tearing. (Fig. 3)

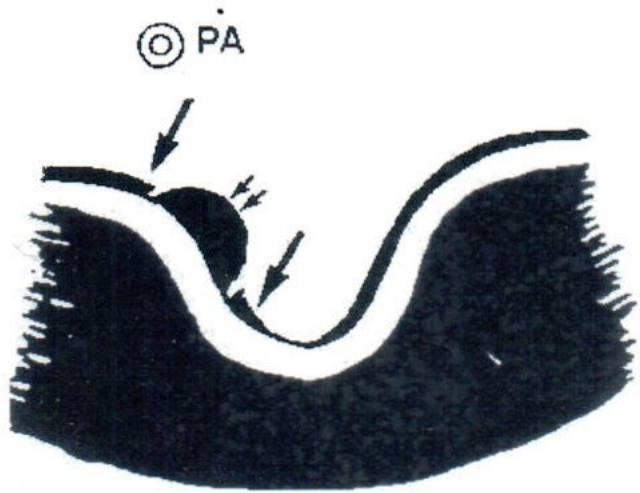
Fig. 3 B Anatomic drawing of sonographic findings in A : Convex collection (small arrows) is hematoma at ACL origin. It obscures covering synovium (Large arrows)

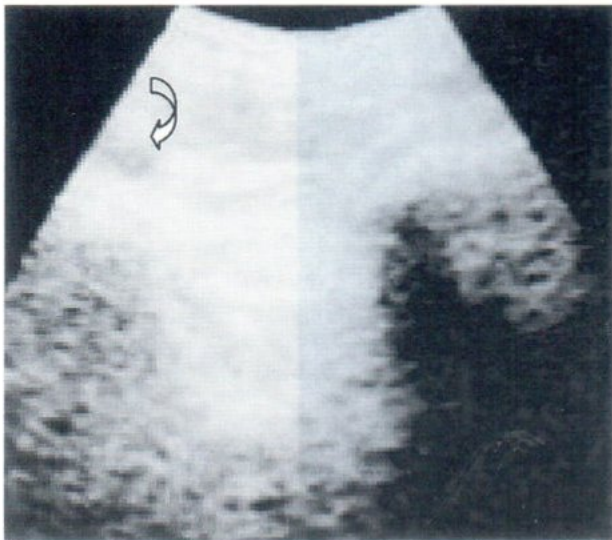
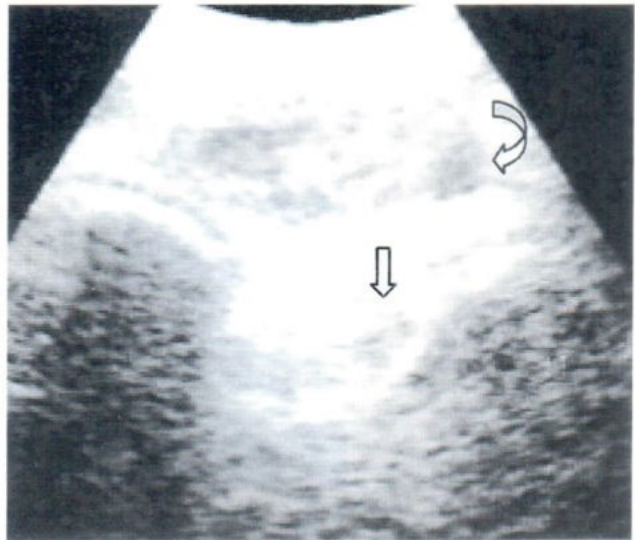
Fig. 4 Transverse scan of the intercondylar notch of patient number 14 showed no abnormal echogenicity of left knee (A). A hypoechoic collection (white arrow) at lateral wall of the femoral intercondylar notch of right knee represents hematoma at ACL origin.

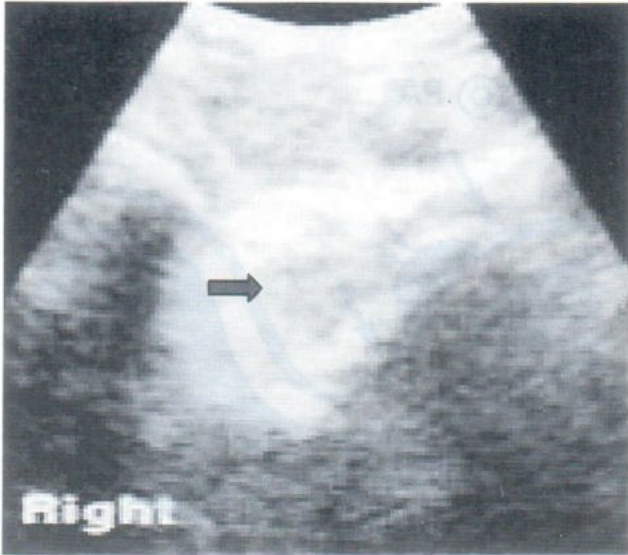
Fig.5A Sonogram of case 7. showed a 15x20 mm. convex hypoechoic collection (black arrow) at the ACL origin of right knee, which was a hematoma together with a ligament stump. The sonographic finding was confirmed by knee operation.

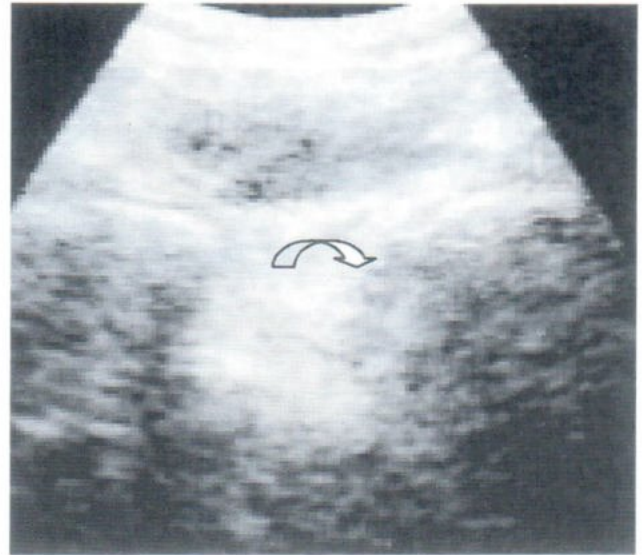
Fig.5B Case 3. Sonogram of right knee showed fusiform hypoechoic collection (curved arrow) at lateral wall of the intercondylar notch and knee operation revealed midsubstance tear of the right ACL.

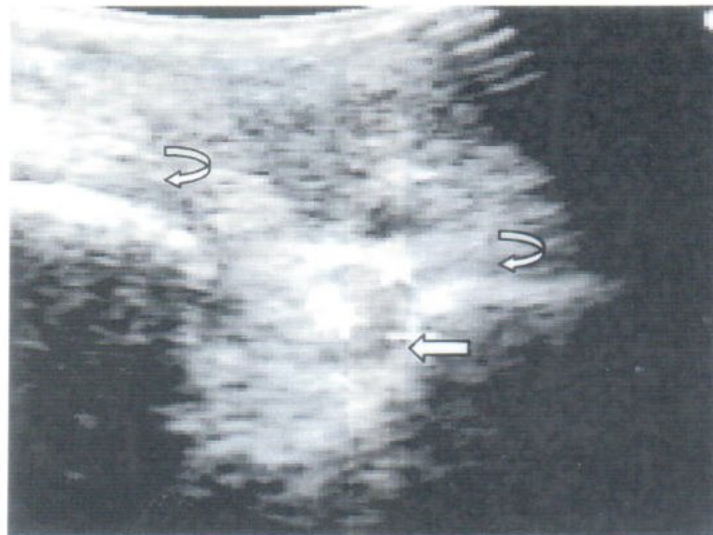
Fig.6 Case 1. Sonogram of right knee showed a 4.7x11 mm. hypoechoic collection at origin of right ACL (white arrow) and thickening of the hypoechoic synovium (curved arrow). The findings represented hematoma at ACL origin and joint effusion, respectively. Knee operation revealed midsubstance tear of right ACL and a hematoma at ACL origin.
